Metallosis after reverse total shoulder arthroplasty

Alexander J. Rondon, Tyler R. Clark, Felix H. Savoie

Rondon AJ, Clark TR, Savoie FH. Metallosis after reverse total shoulder arthroplasty. *Edorium J Orthop* 2017;3:17–23.

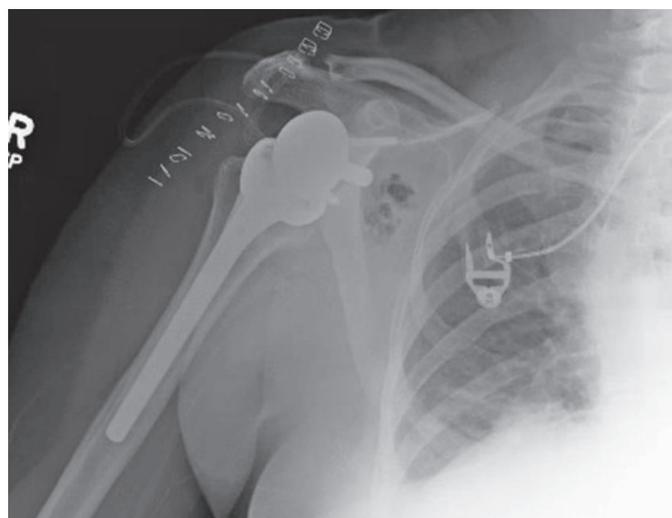
Figure 1: Postoperative radiograph for primary reverse total shoulder arthroplasty.

The reverse total shoulder arthroplasty was performed with a reverse shoulder prosthesis (Figure 1). Her postoperative course was initially uncomplicated. Three-week and five-month follow-up radiographic examination revealed intact prosthesis (Figures 2 and 3).

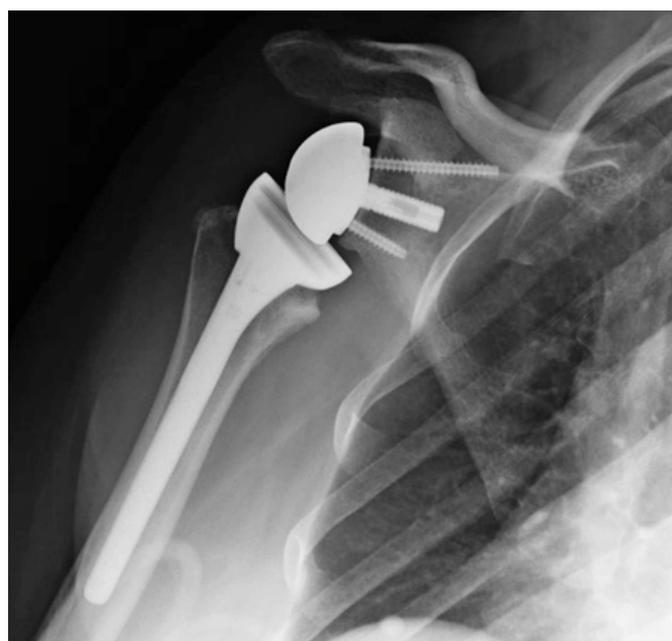
Figure 2: Three-week follow-up postoperative radiograph for primary reverse total shoulder arthroplasty.

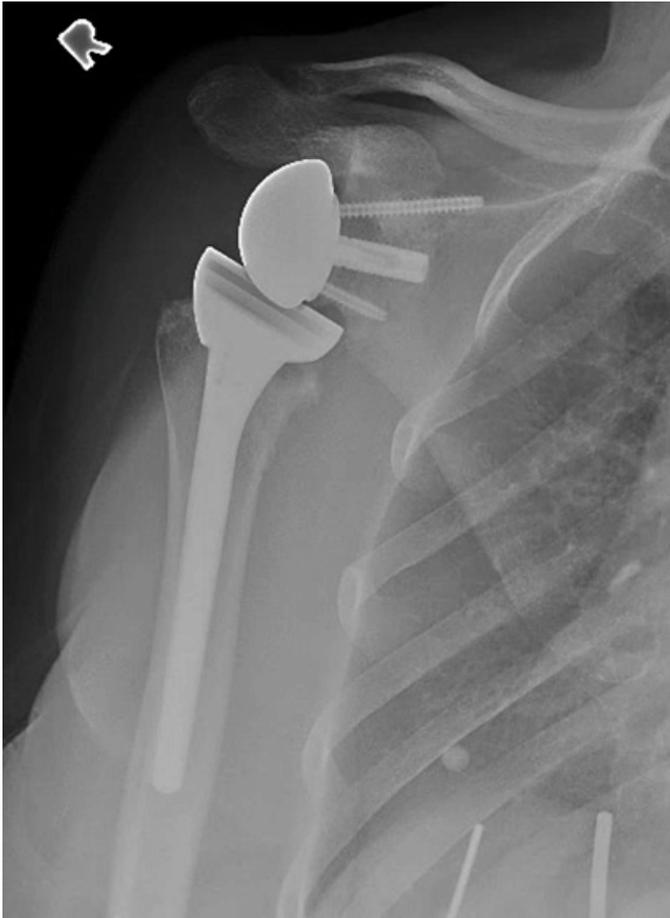
Figure 3: Five-month follow-up postoperative radiograph for primary reverse total shoulder arthroplasty.

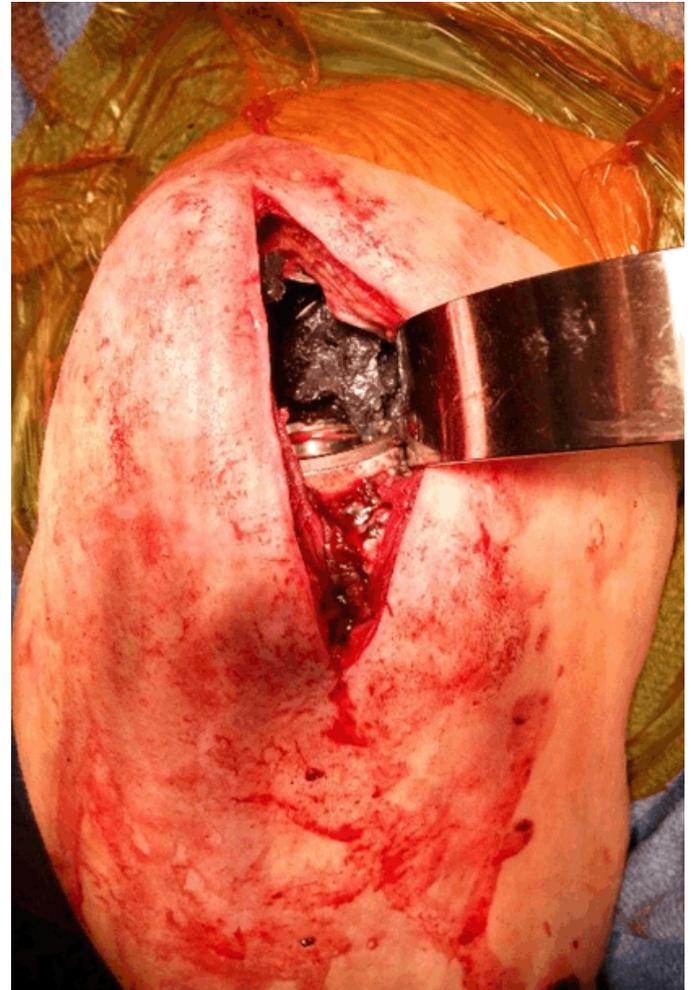
Figure 5: Intraoperative image during revision reverse total shoulder arthroplasty.

Given the elevated humeral component and clinical instability of the shoulder, the decision to return to the operating room for revision surgery was taken. Initial concerns for infection were high. Prior to surgery, laboratory results were taken to rule out infection and were unremarkable. She was taken to the operating room for a liner exchange and increase in the glenosphere from 36–42 due to concern of under sizing of liner. During surgery, severe metallic staining was detected in the intra-articular cavity and in the extra-articular tissues (Figures 5 and 6). The polyethylene cup was removed and found to have some wear on the inferior surface (Figure 7). A diagnosis of metallosis of reverse total shoulder arthroplasty was made. The metallic, blackened tissue was removed and sent for frozen section (Figure 8). The prosthesis were exchanged. Pathology reported the tissue frozen section sample contained fibrin clots with macrophages containing black-green cytoplasmic pigment consistent with origin from detritus-like change.

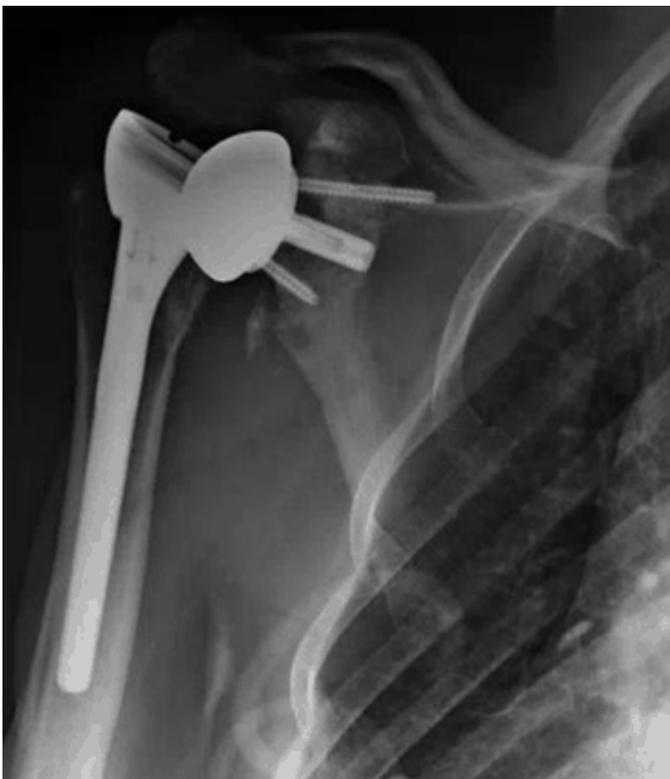
Seven months postoperatively, the patient reported a muscle spasm in her right shoulder while at the grocery store where her right shoulder spontaneously dislocated. Examination of the right shoulder revealed the shoulder in a shortened internally rotated position. The prosthesis was palpable and dislocated anteriorly. Plain radiographs revealed dislocated right shoulder prosthesis (Figure 4), which was later manually reduced via closed reduction in the emergency room.

Figure 4: Primary reverse total shoulder arthroplasty dislocation.

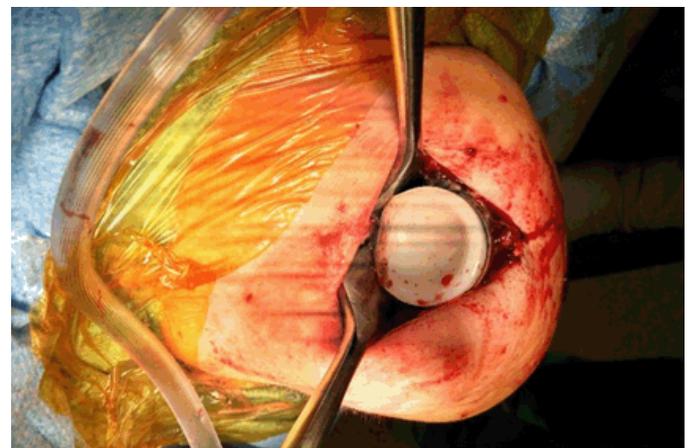
Figure 6: Intraoperative image during revision reverse total shoulder arthroplasty.

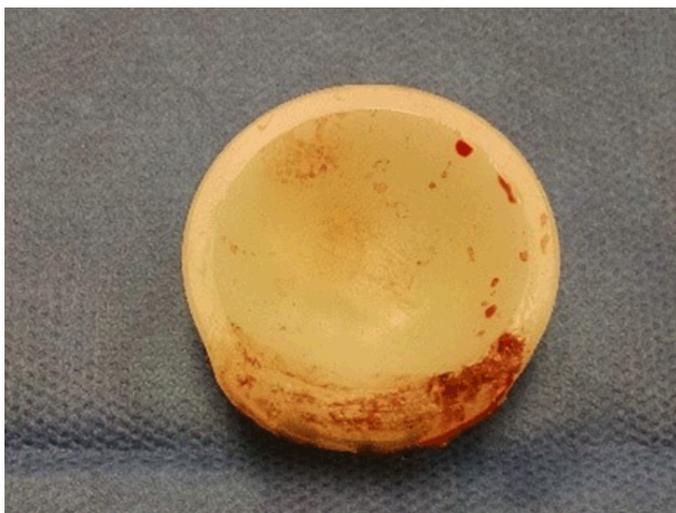
Figure 7: Polyethylene cup with inferior wear removed during revision reverse total shoulder arthroplasty.

During surgery, severe metallic staining was discovered in the joint confirming the diagnosis of metallosis as well as significant inferomedial wear to the polyethylene insert. This was likely due to instability as a result of inadequate tension on the deltoid muscle, inadequate liner size, early hypermobility, downward tilt of the glenoid, and failure to lateralize the component sufficiently [14]. Pathology reported the tissue collected during surgery contained fibrin clots with macrophages containing black-green cytoplasmic pigment consistent with origin from detritus-like change. It is important to note that three month post-operative bloodwork for chromium did return slightly elevated, however, were still within normal limit range. A review article by Jantzen et al. examined 43 separate studies examining metal-on-metal implants and metal ion concentrations in blood and serum. It was concluded in the article that ion concentrations at which toxicity is induced are not yet known, so safe levels of cobalt and chromium cannot be determined [19].

It is our hypothesis that the glenoid component articulated with the metal humeral neck due to asymmetric polyethylene wear of the humeral cup. This likely led to metal on metal wear and allowed the release of metal ions into the local environment. Gutierrez et al. describe the most effective method to avoid adduction impingement is to have humeral neck shaft angle of 130 degrees, followed by inferior glenosphere position, 10 mm lateral offset center of rotation, and 42 mm diameter glenosphere [17, 18, 20]. In this case, a DePuy Unite reverse shoulder prosthesis was utilized. The humeral shaft angle of 135° was achieved along with a 10 mm lateral offset center for rotation, however, a 36 mm glenosphere was used.

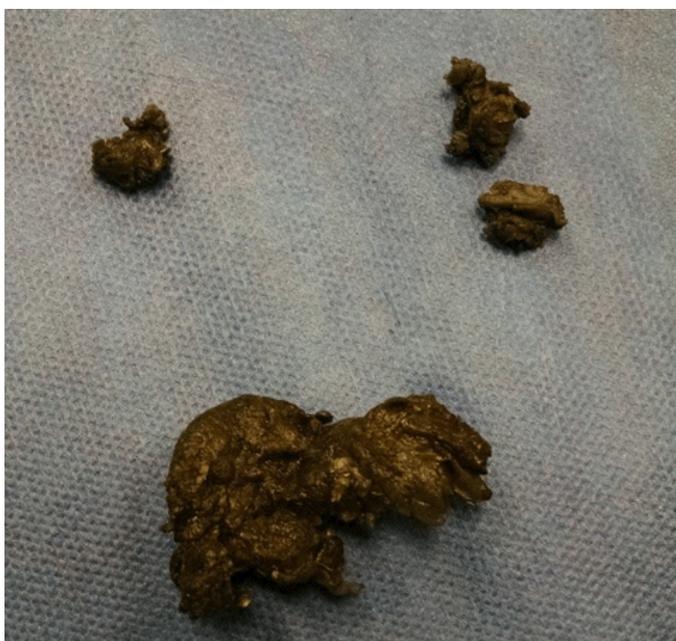
Figure 8: Blackened fibroconnective tissue collected during revision reverse total shoulder arthroplasty.
