Metallosis after reverse total shoulder arthroplasty

Alexander J. Rondon, Tyler R. Clark, Felix H. Savoie

Rondon AJ, Clark TR, Savoie FH. Metallosis after reverse total shoulder arthroplasty. *Edorium J Orthop* 2017;3:17–23.

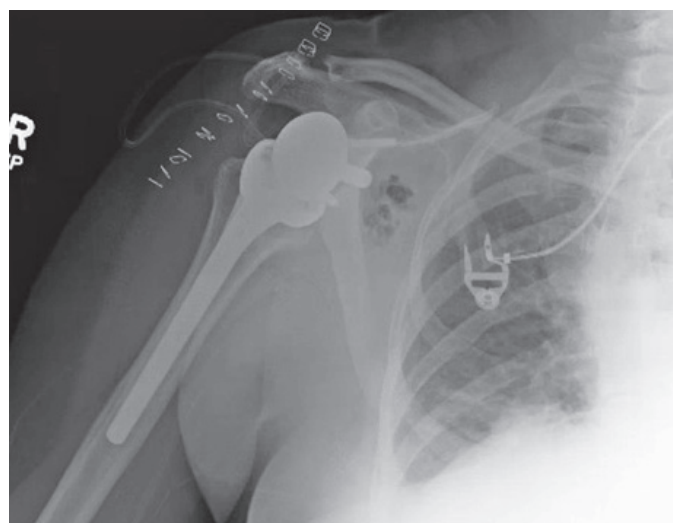
Figure 1: Postoperative radiograph for primary reverse total shoulder arthroplasty.

The reverse total shoulder arthroplasty was performed with a reverse shoulder prosthesis (Figure 1). Her postoperative course was initially uncomplicated. Three-week and five-month follow-up radiographic examination revealed intact prosthesis (Figures 2 and 3).

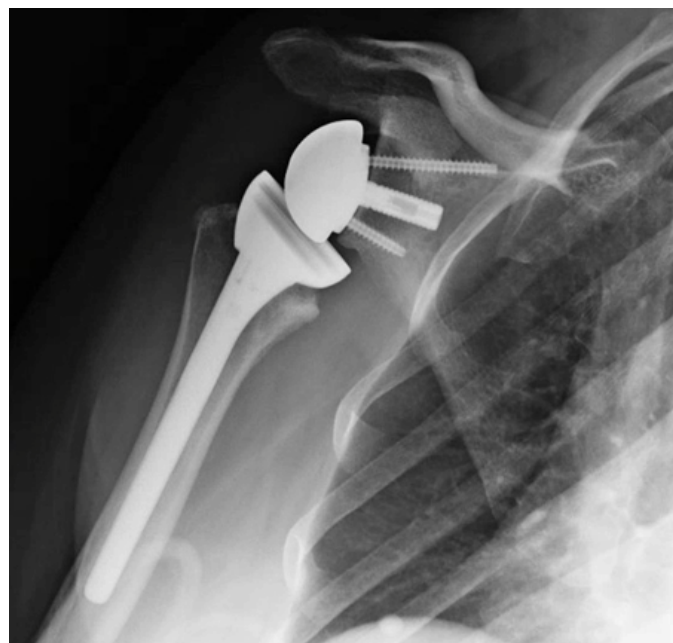
Figure 2: Three-week follow-up postoperative radiograph for primary reverse total shoulder arthroplasty.

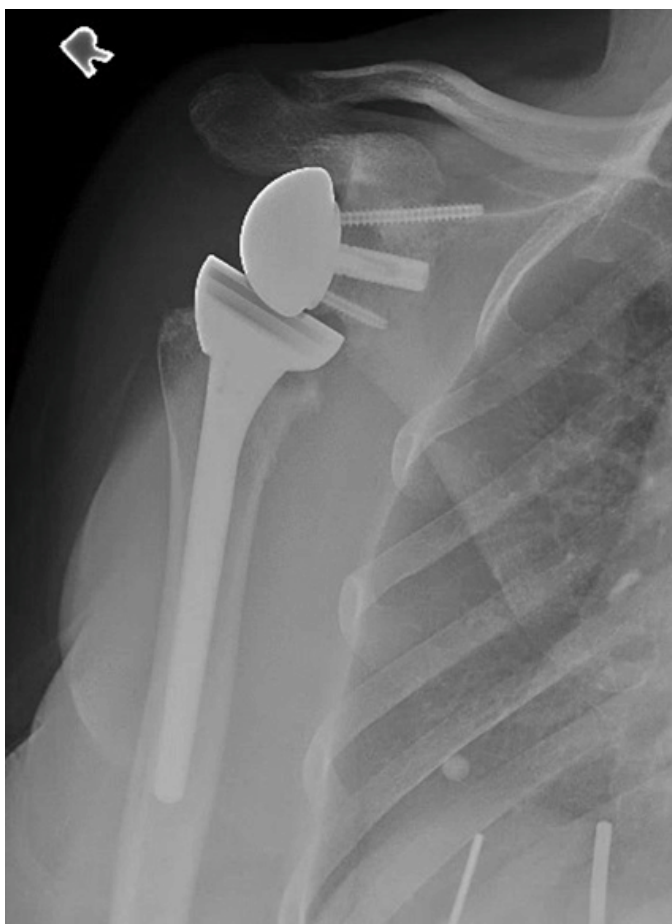
Figure 3: Five-month follow-up postoperative radiograph for primary reverse total shoulder arthroplasty.

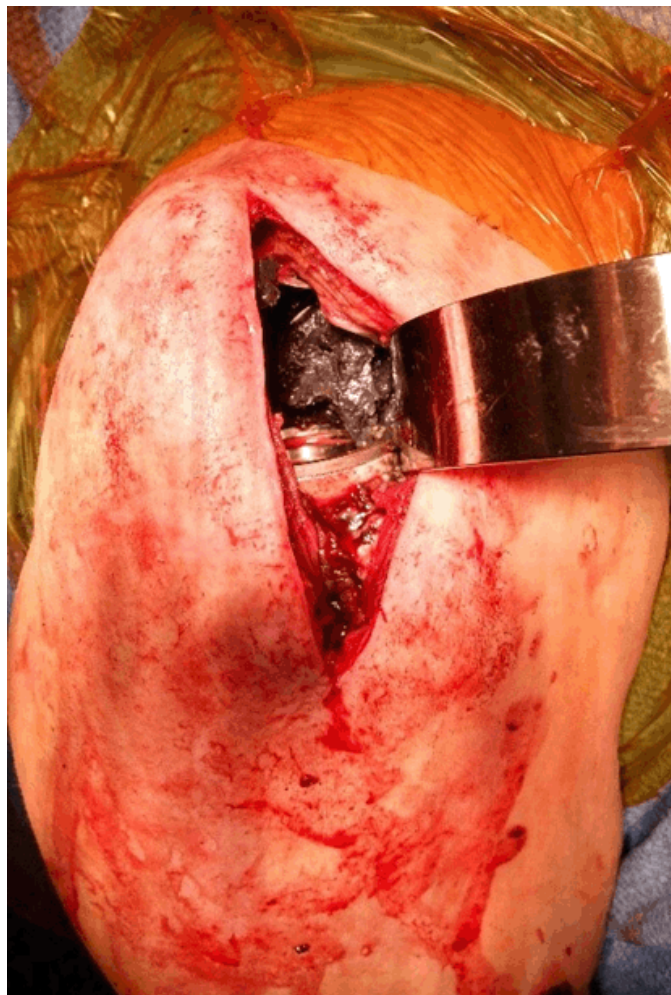
Figure 5: Intraoperative image during revision reverse total shoulder arthroplasty.

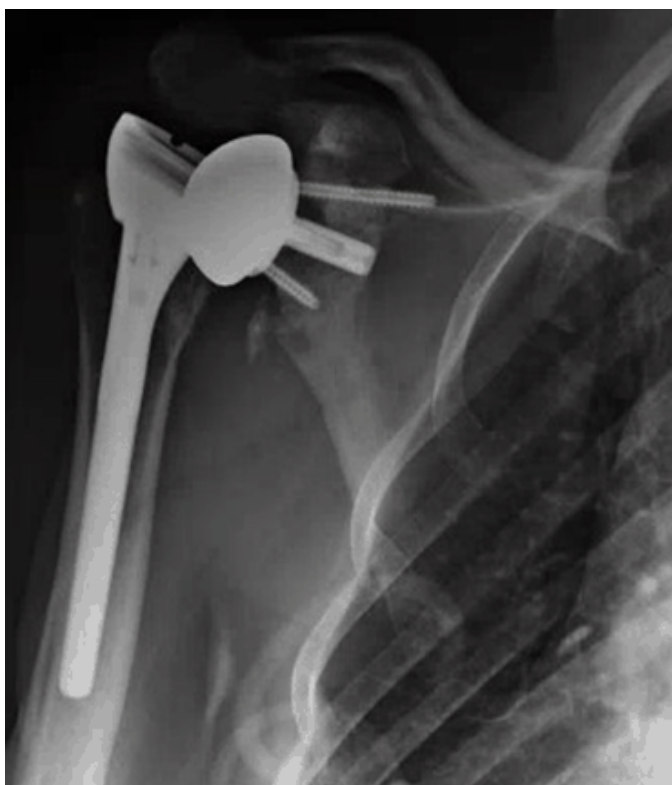
Seven months postoperatively, the patient reported a muscle spasm in her right shoulder while at the grocery store where her right shoulder spontaneously dislocated. Examination of the right shoulder revealed the shoulder in a shortened internally rotated position. The prosthesis was palpable and dislocated anteriorly. Plain radiographs revealed dislocated right shoulder prosthesis (Figure 4), which was later manually reduced via closed reduction in the emergency room.

Figure 4: Primary reverse total shoulder arthroplasty dislocation.

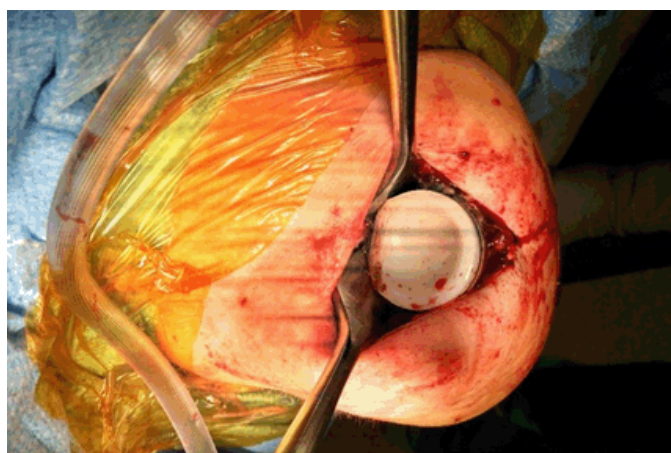
Figure 6: Intraoperative image during revision reverse total shoulder arthroplasty.

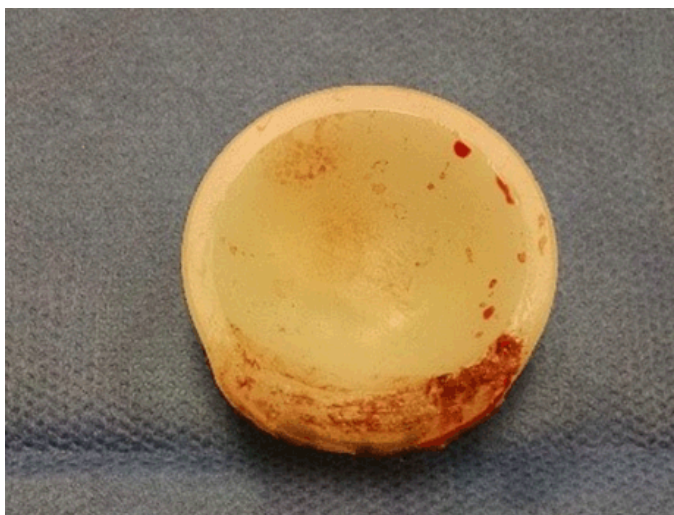
Figure 7: Polyethylene cup with inferior wear removed during revision reverse total shoulder arthroplasty.

During surgery, severe metallic staining was discovered in the joint confirming the diagnosis of metallosis as well as significant inferomedial wear to the polyethylene insert. This was likely due to instability as a result of inadequate tension on the deltoid muscle, inadequate liner size, early hypermobility, downward tilt of the glenoid, and failure to lateralize the component sufficiently [14]. Pathology reported the tissue collected during surgery contained fibrin clots with macrophages containing black-green cytoplasmic pigment consistent with origin from detritus-like change. It is important to note that three month post-operative bloodwork for chromium did return slightly elevated, however, were still within normal limit range. A review article by Jantzen et al. examined 43 separate studies examining metal-on-metal implants and metal ion concentrations in blood and serum. It was concluded in the article that ion concentrations at which toxicity is induced are not yet known, so safe levels of cobalt and chromium cannot be determined [19].

It is our hypothesis that the glenoid component articulated with the metal humeral neck due to asymmetric polyethylene wear of the humeral cup. This likely led to metal on metal wear and allowed the release of metal ions into the local environment. Gutierrez et al. describe the most effective method to avoid adduction impingement is to have humeral neck shaft angle of 130 degrees, followed by inferior glenosphere position, 10 mm lateral offset center of rotation, and 42 mm diameter glenosphere [17, 18, 20]. In this case, a DePuy Unite reverse shoulder prosthesis was utilized. The humeral shaft angle of 135° was achieved along with a 10 mm lateral offset center for rotation, however, a 36 mm glenosphere was used.

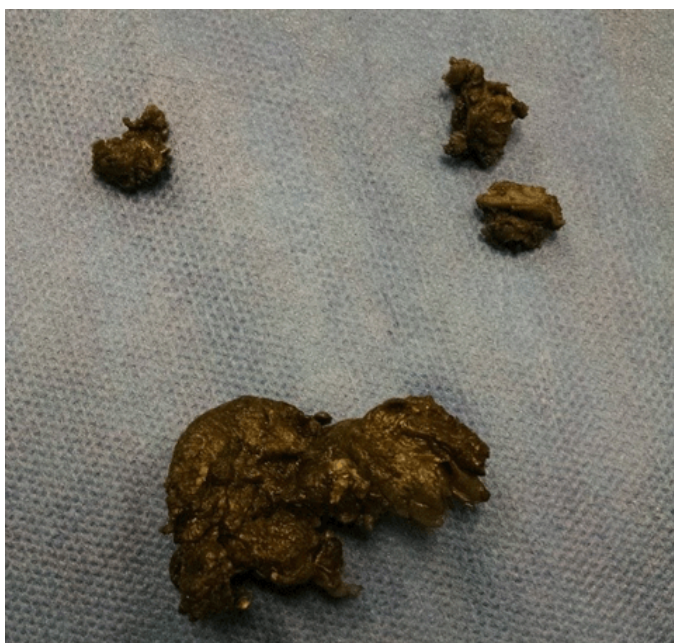
Given the elevated humeral component and clinical instability of the shoulder, the decision to return to the operating room for revision surgery was taken. Initial concerns for infection were high. Prior to surgery, laboratory results were taken to rule out infection and were unremarkable. She was taken to the operating room for a liner exchange and increase in the glenosphere from 36–42 due to concern of under sizing of liner. During surgery, severe metallic staining was detected in the intra-articular cavity and in the extra-articular tissues (Figures 5 and 6). The polyethylene cup was removed and found to have some wear on the inferior surface (Figure 7). A diagnosis of metallosis of reverse total shoulder arthroplasty was made. The metallic, blackened tissue was removed and sent for frozen section (Figure 8). The prosthesis were exchanged. Pathology reported the tissue frozen section sample contained fibrin clots with macrophages containing black-green cytoplasmic pigment consistent with origin from detritus-like change.

Figure 8: Blackened fibroconnective tissue collected during revision reverse total shoulder arthroplasty.
